# PIC16F631/677/685/687/689/690

## PIC16F631/677/685/687/689/690 Family Silicon Errata and Data Sheet Clarification

The PIC16F631/677/685/687/689/690 family devices that you have received conform functionally to the current Device Data Sheet (DS41262E), except for the anomalies described in this document.

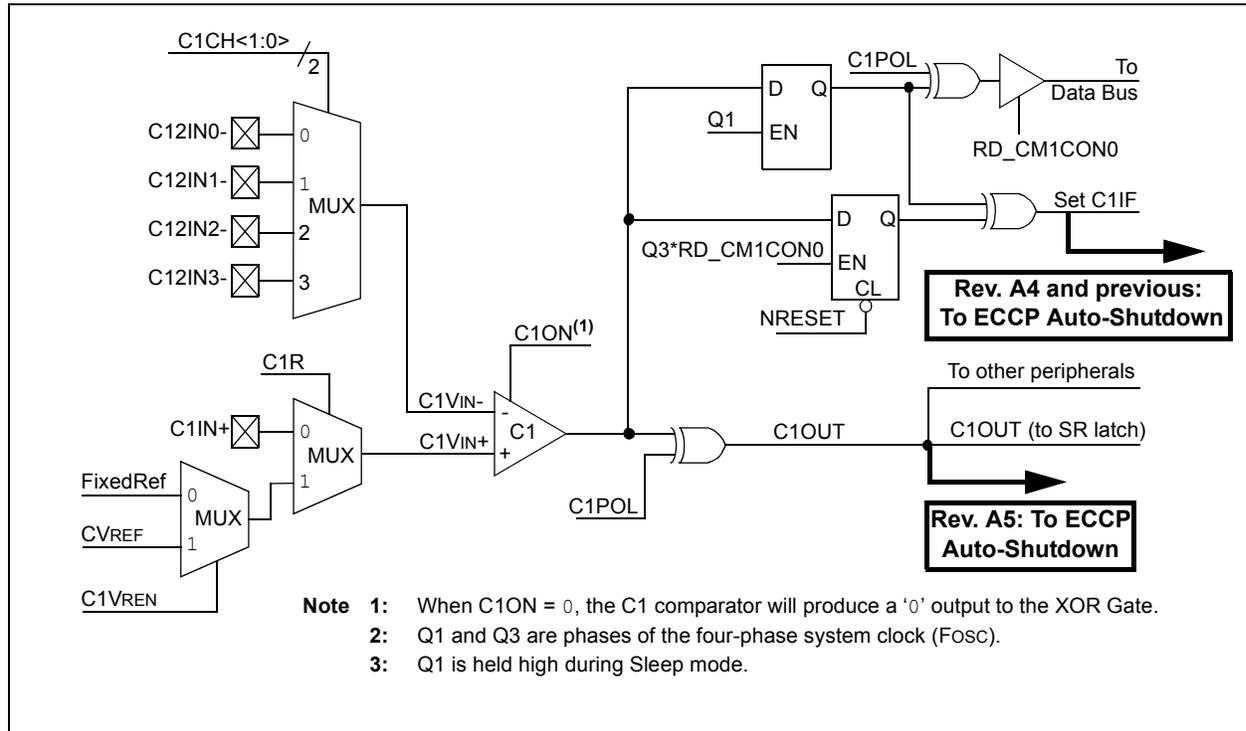
FIGURE 8-2: COMPARATOR C1 SIMPLIFIED BLOCK DIAGRAM

The PIC16F631/677/685/687/689/690 Rev. A4 silicon for the ECCP auto-shutdown is connected to the C1IF and C2IF flags. See Figures 8-2 and 8-3 on the following page.

The auto-shutdown connection (Rev. A4 and previous) to C1IF and C2IF causes the auto-shutdown to incorrectly operate synchronously. Additionally, reads of CMxCON0 will incorrectly clear an auto-shutdown event.

- 1) Poll the CxOUT bit until it is low.
- 2) Read CMxCON0 to precondition CxIF.
- 3) If CMxCON0 is read while CxOUT is changing, repeat steps 1 and 2.

The Silicon Rev. A5 (now shipping) and later revision devices have moved the auto-shutdown connection from CxIF to CxOUT. This will eliminate the synchronous shutdown and simplify the use of the comparator for a shutdown event. Figure 1 shows the function of auto-shutdown before and after the device revision.
