## PIC18F87J11 Family Silicon Errata and Data Sheet Clarification

The PIC18F87J11 family of devices that you have received conform functionally to the current Device Data Sheet (DS39778E), except for the anomalies described in this document.

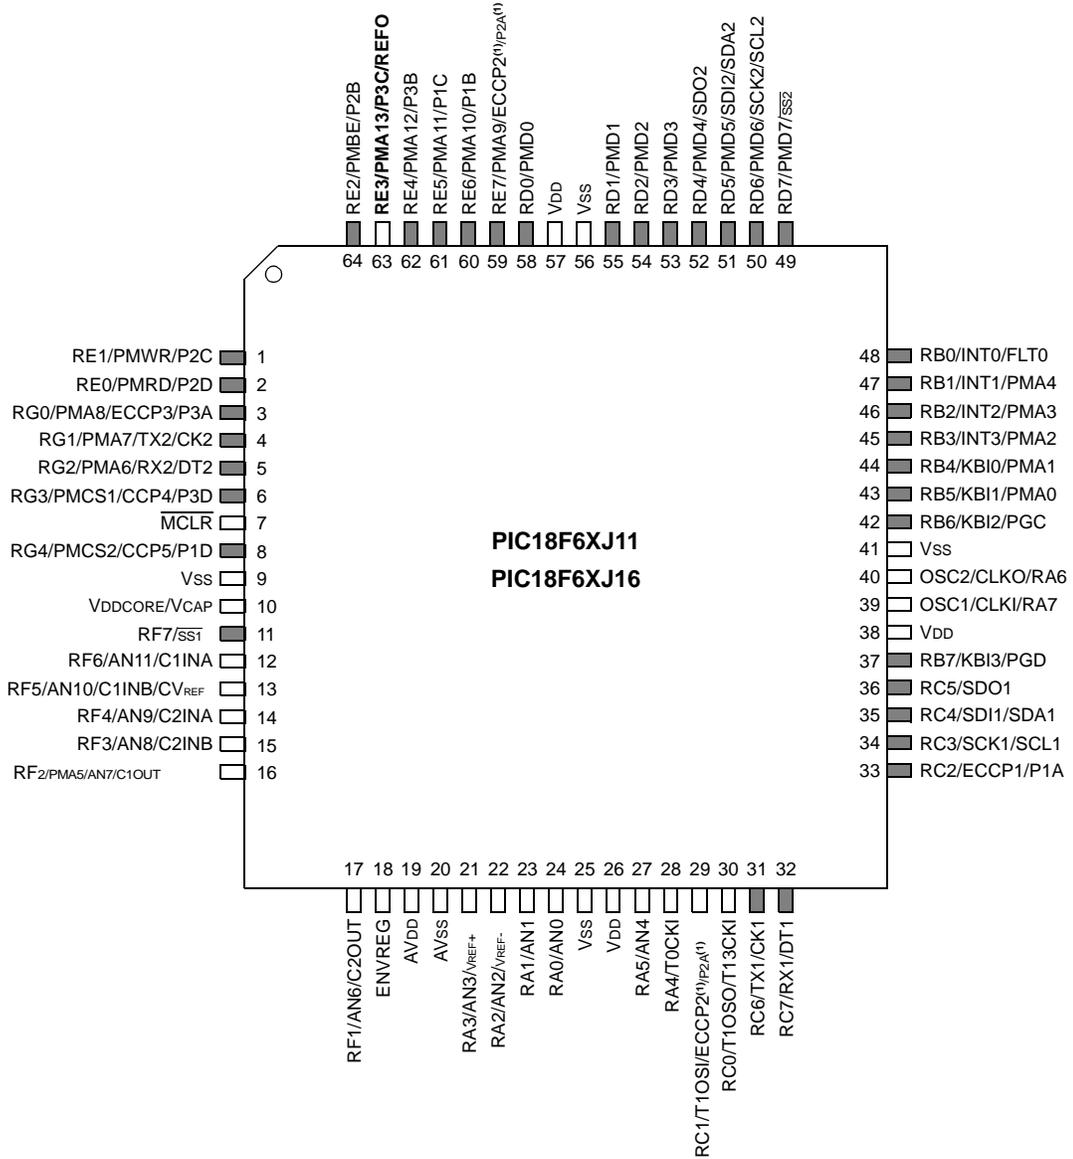
## 64-Pin TQFP

PORTE pin RE3 is not +5.5V tolerant as indicated in the data sheet. The pin diagrams should be corrected to read as follows:
