PIC18(L)F24/25/45K50 Family Silicon Errata and Data Sheet Clarification

The PIC18(L)F24/25/45K50 family devices that you have received conform functionally to the current Device Data Sheet (DS30684A), except for the anomalies described in this document.

The silicon issues discussed in the following pages are for silicon revisions with the Device and Revision IDs listed in [Table 1](#). The silicon issues are summarized in [Table 2](#).

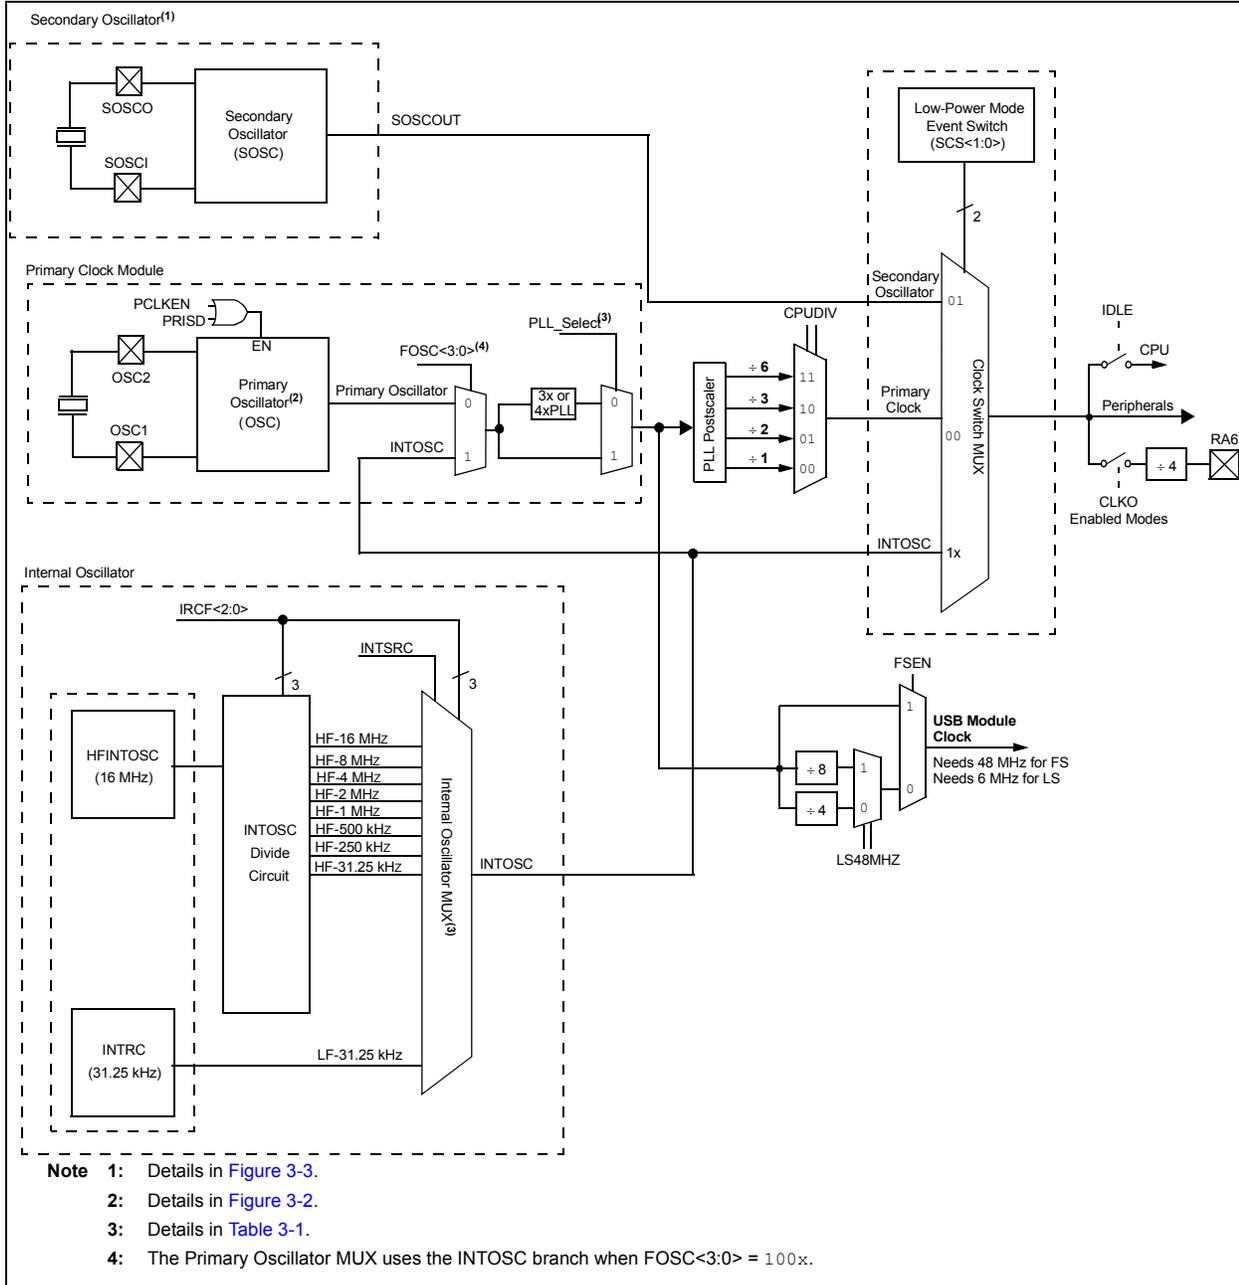
FIGURE 3-1: SIMPLIFIED OSCILLATOR SYSTEM BLOCK DIAGRAM

1. Module: CPU Divider

[Figure 3-1](#) from **Section 3.1 “Overview”**, as well as [Table 3-6](#) and [Table 3-7](#) from **Section 3.14.1 “Low-Speed Operation”** have incorrect data on the CPUDIV Configuration bits. The corrected versions are below:
