dsPIC33EPXXX(GP/MC/MU)806/810/814 and PIC24EPXXX(GP/GU)810/814 Family Silicon Errata and Data Sheet Clarification

The dsPIC33EPXXX(GP/MC/MU)806/810/814 and PIC24EPXXX(GP/GU)810/814 family devices that you have received conform functionally to the current Device Data Sheet (DS70616G), except for the anomalies described in this document.

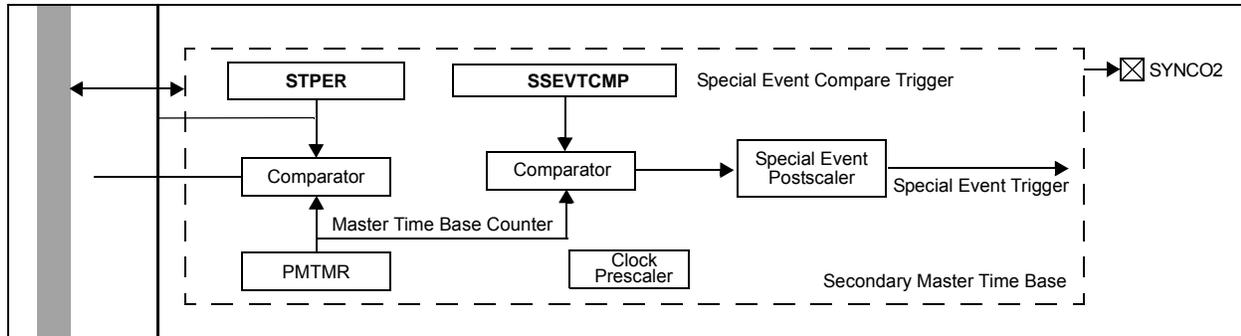
FIGURE 16-2: HIGH-SPEED PWM MODULE REGISTER INTERCONNECTION DIAGRAM

In **Figure 16-2: High-Speed PWM Module Register Interconnection Diagram**, the Secondary Master Time Base section has been updated. The updated text is shown in **bold** in [Figure 16-2](#) below.
